## N54 (335i and 135i) Inlet Valve Intensive Cleaning

### The Problem.

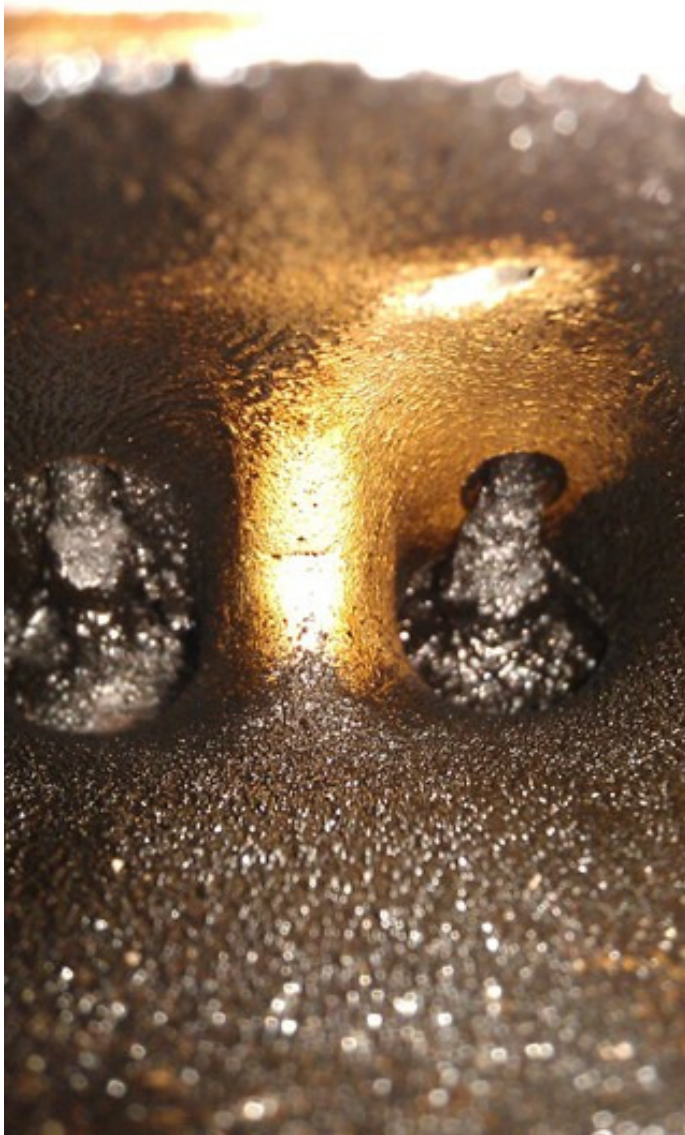
It has already been widely acknowledged that BMW engines with Direct Injection Technology can suffer from contamination of inlet valves. This issue has been known to occur at quite low mileages, where the engine has not been used enthusiastically. The level of contamination at 50,000 miles will almost always create erratic cold start and idle performance.

Before Treatment

We do not follow the logic of this BMW measure, and have developed our own procedure for the cleaning process without removal of the cylinder head. Our process involves removal of the manifold, and manual cleaning of the substantial residues, followed by a chemical cleaning of the remaining residues. Our cleaning procedure costs up to £550 including VAT, depending on the level of contamination. The results are immediately noticeable, and often lost fuel economy and performance can be restored.

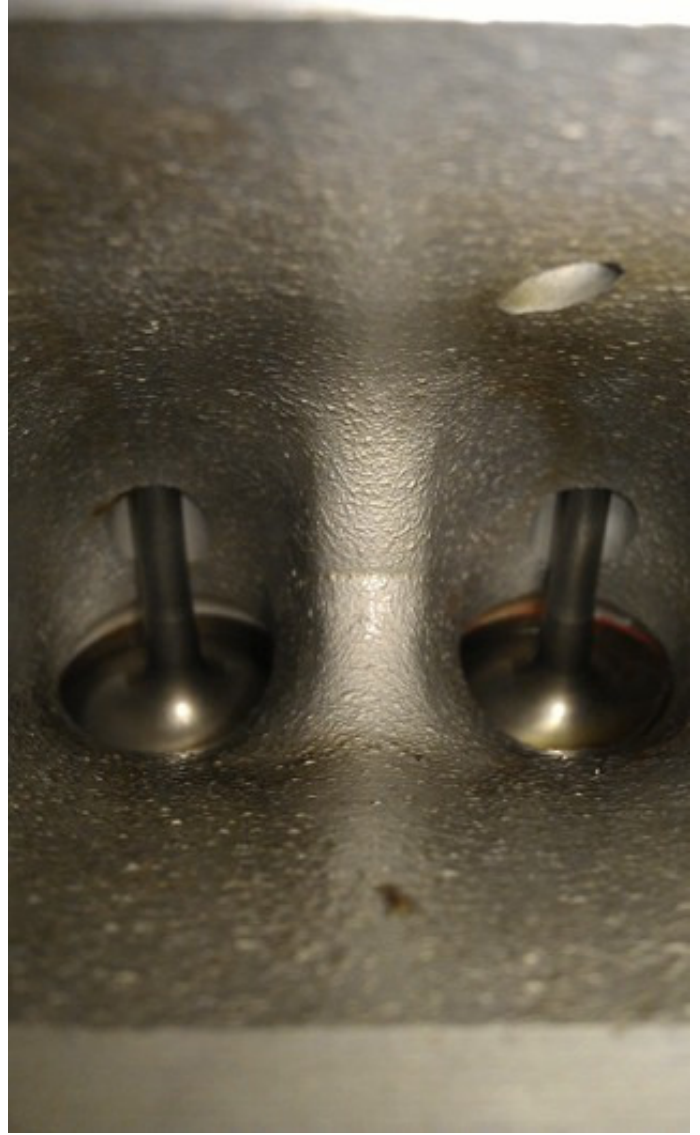
After Treatment
